JimWalter Resources # 5 Coal Mine Disaster

September 23, 2001;

A United Mine Workers of America Report

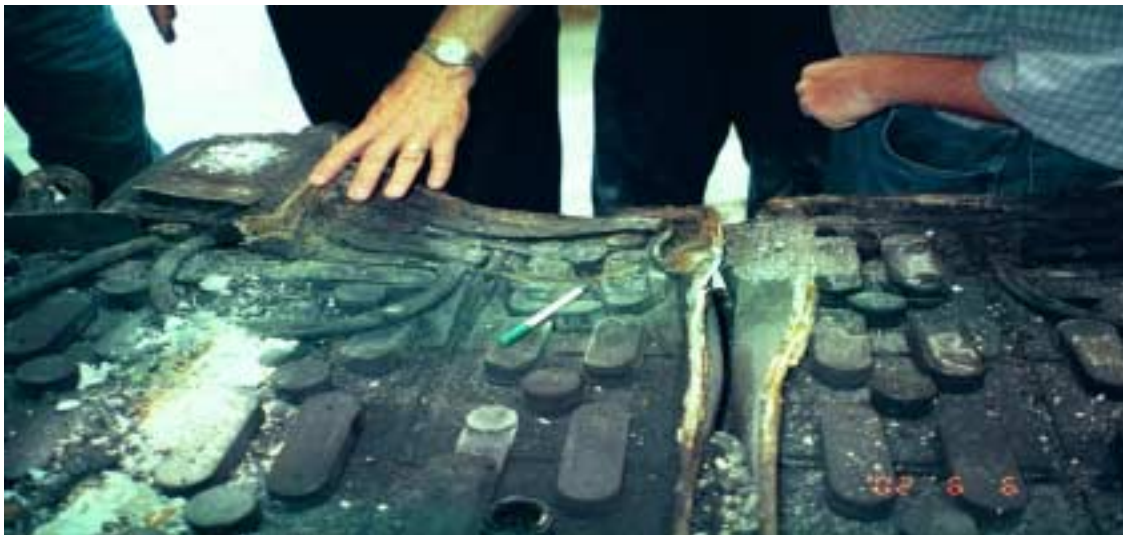
It is believed that the scoop battery, which was hung from the roof that fell, was the likely ignition source of the first explosion. It is considered the likely ignition source due to its proximity to methane that likely migrated from the roof fall. The restricted ventilation in the area, damage to the battery terminals and leads caused a short-circuited capable of generating sufficient heat to ignite methane.

The picture below shows the damaged battery cells from the roof fall that likely caused a short circuit to the straps, allowing them to arc and become an ignition source.

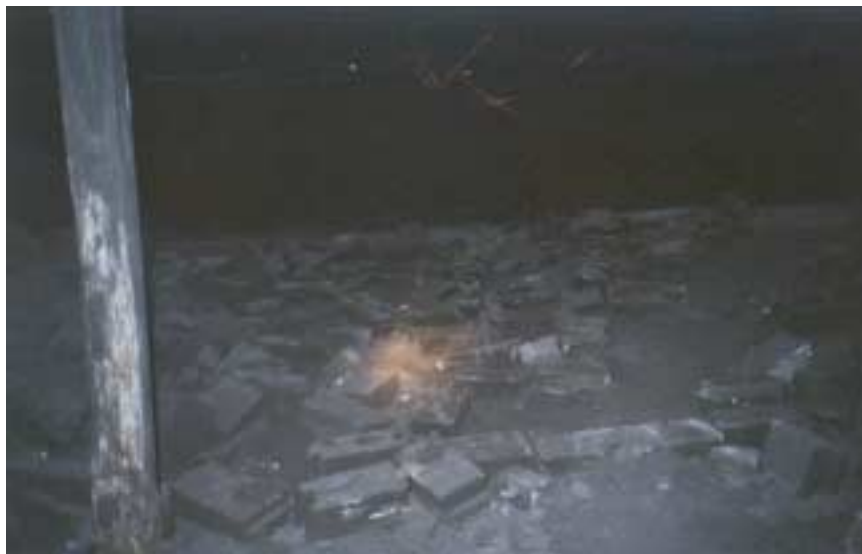
Figure 1:
Concrete block blown from a
stopping between #1 and #2 entry,
taken from the #2 entry at spad
#13295.

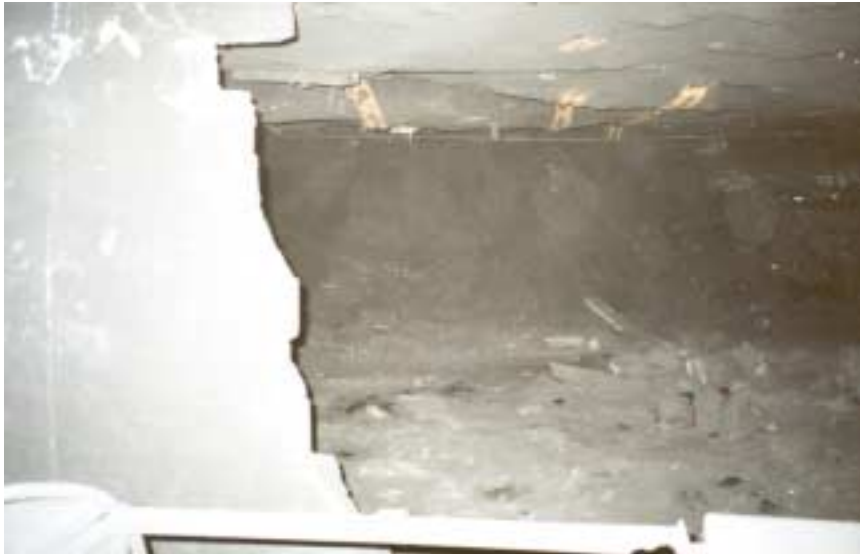
Figure 2: Partial concrete block stopping behind the section power center looking toward the #1 entry.

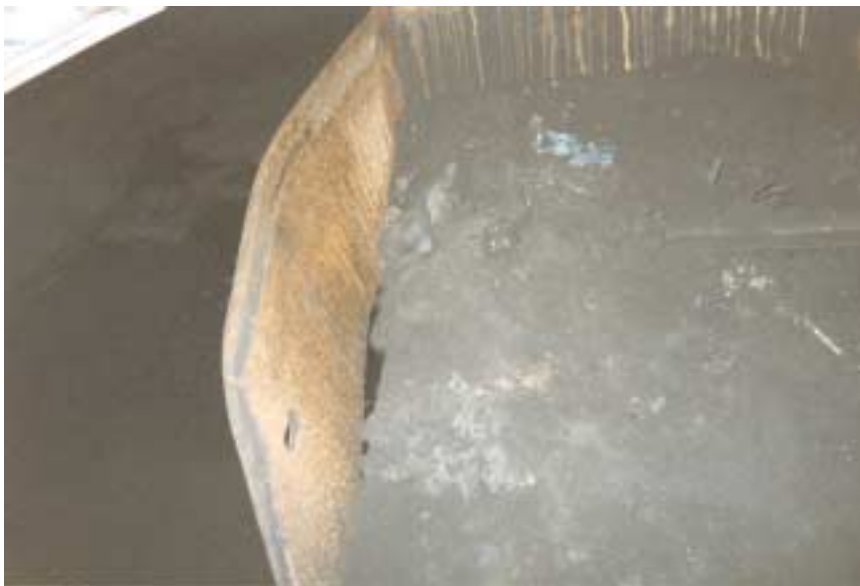
Figure 3: Damage to the outby side plate of scoop bucket.

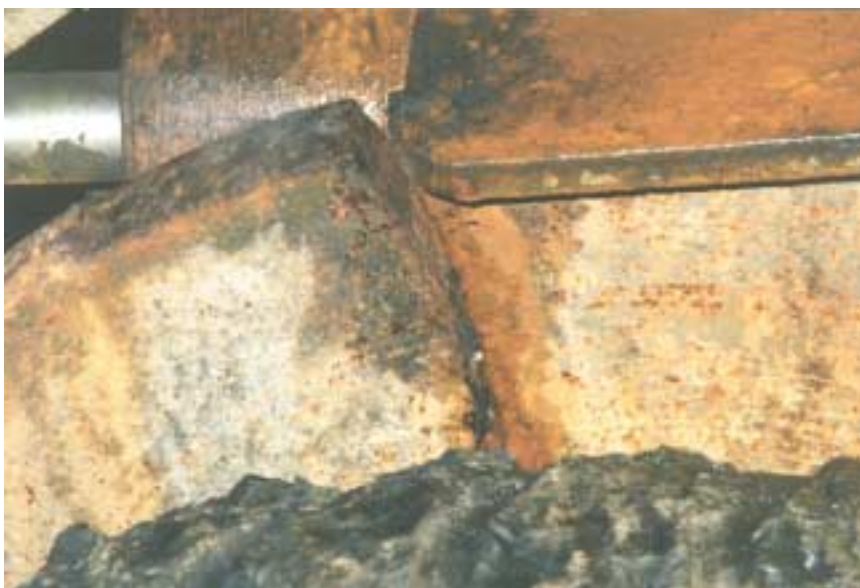
Figure 4: Crack in frame on the bucket end of scoop (inby side).

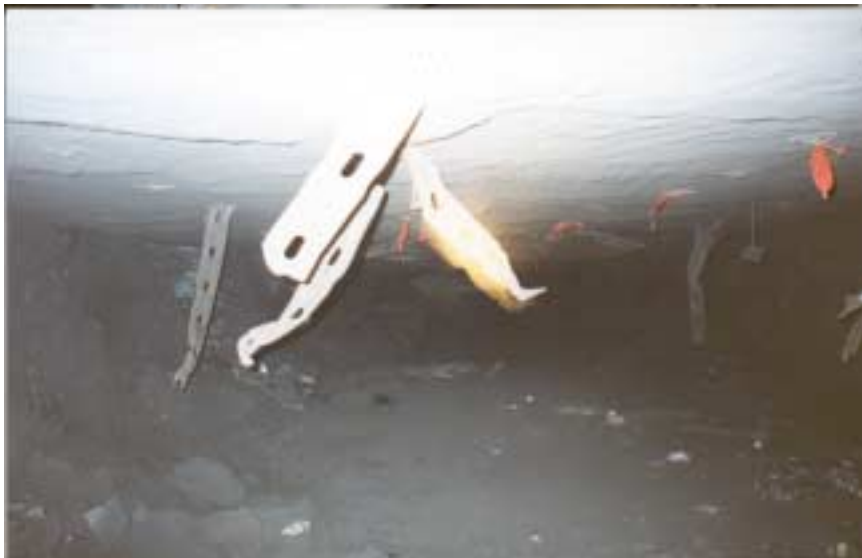
Figure 7: Metal channels shredded and torn in the last open crosscut between #2 and #3 entry. Looking from the #2 side approximately 20 feet into the crosscut. The red flagging indicates loose roof bolt plates.

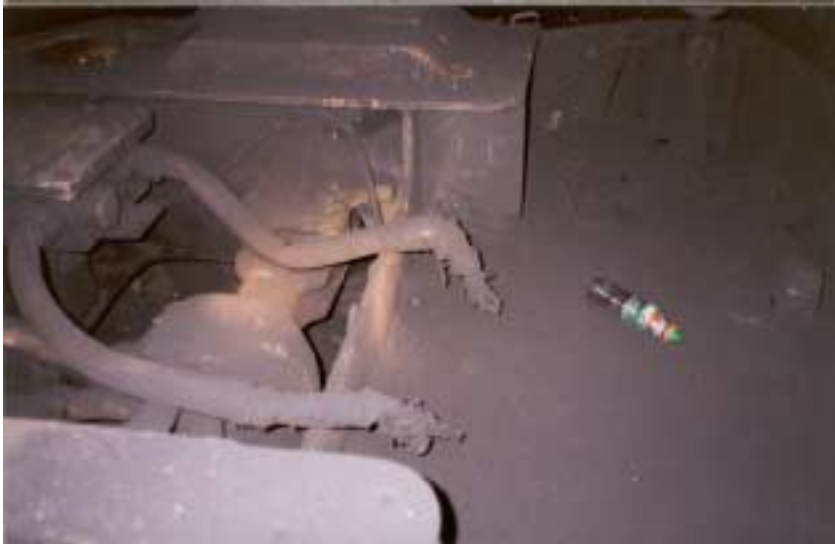
Figure 8: Battery end of scoop facing #1 entry. No battery and battery leads pulled loose from battery. Scoop located at spad #13352 toward #1 entry.

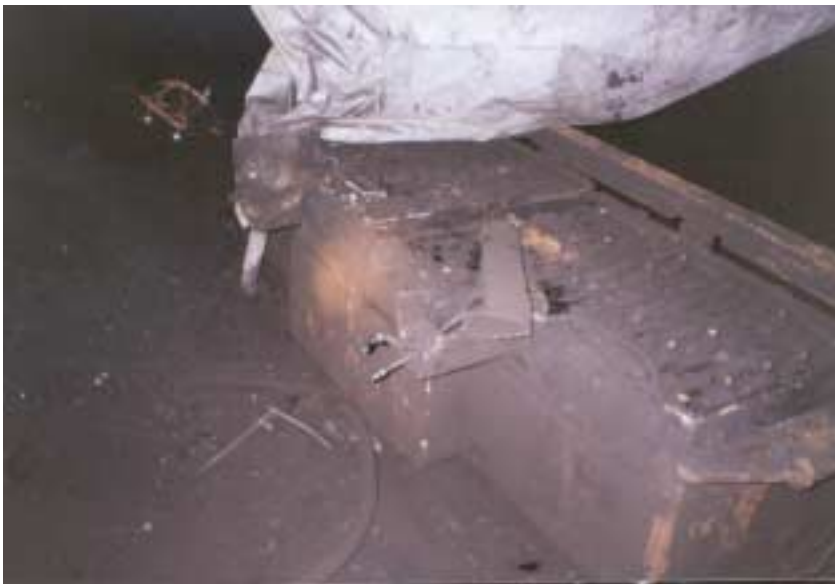
Figure 9: Scoop battery located in the last open crosscut between #2 entry (spad #13352) and #1 entry (spad #13349). This battery was found upside down during recovery operations.

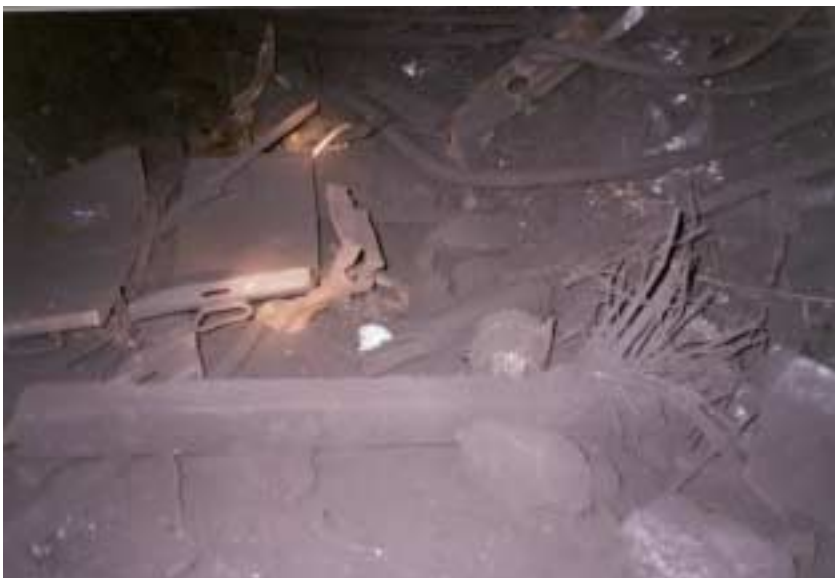
Figure 10: Scoop battery lids, scoop light, and other debris located left of spad #13352 in the #1 entry along the rib.

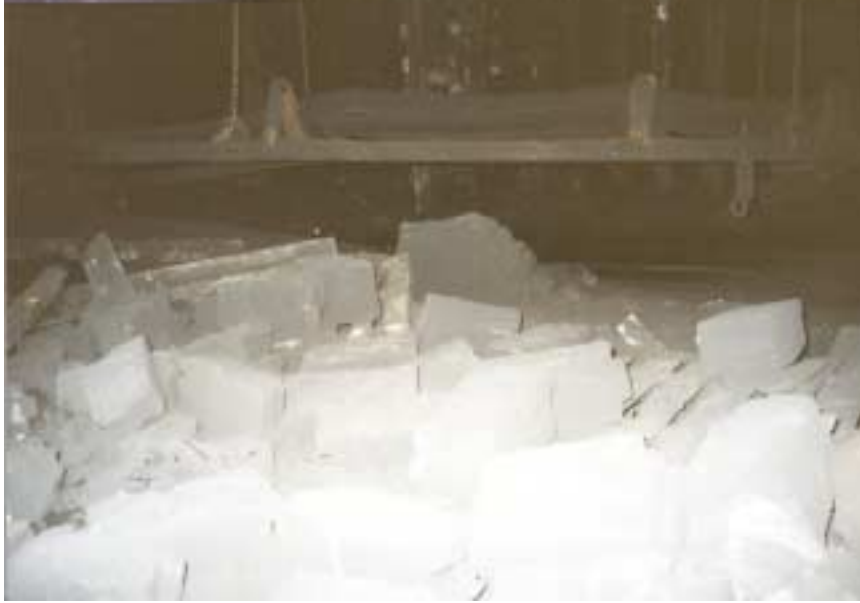
Figure 11: Stopping material deposited in close proximity to where they were originally built. The upper portion of the picture shows the conveyor belt system. This picture was taken from the #4 entry looking into the #3 entry at the crosscut inby spads #13320 and 13318. The picture indicates very little damage to the conveyor belt system.

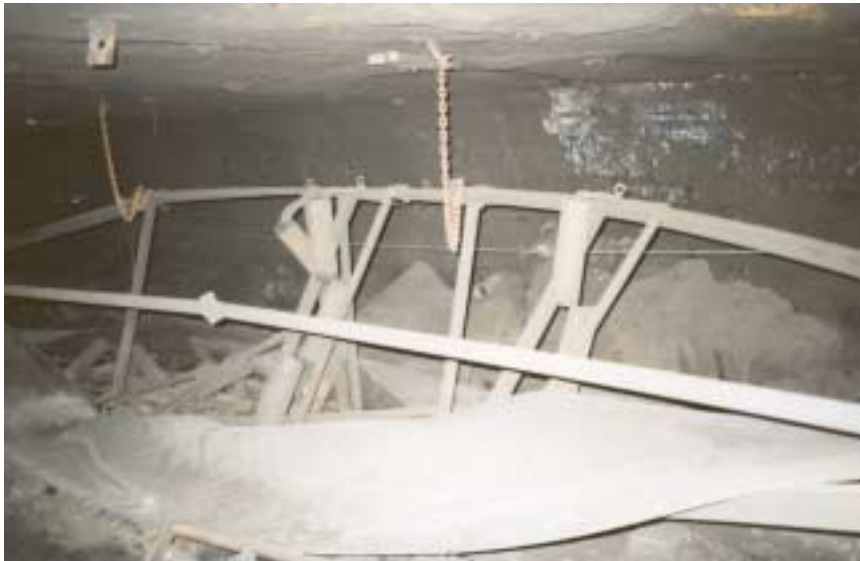
Figure14: Looking into the #3 entry from the crosscut between #3 and #4 entry, to the right of spad #13233. Conveyor belt system is totally destroyed and deposited along the left rib of #3 entry.

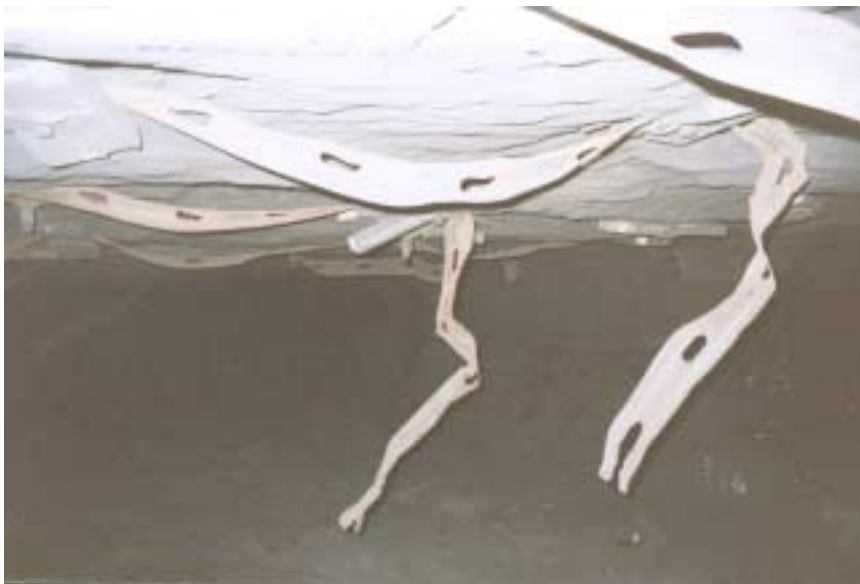
Figure 15: Standing in the #4 entry facing outby at spad #13233, increased damage to the roof straps can be observed.

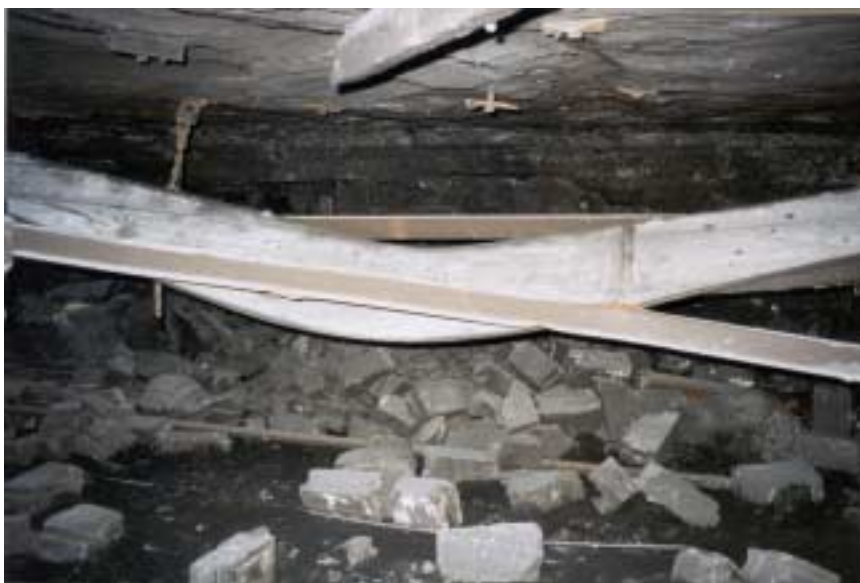
Figure 16: Looking into the #3 entry from the crosscut located between spads #13205 and #13206 stopping material deposited along the left rid of #3 entry. Note: Starting at the outby corner at spad #13206 and extending inby toward spad #13209 in the #4 entry, six broken roof straps were located along the left side of the entry.

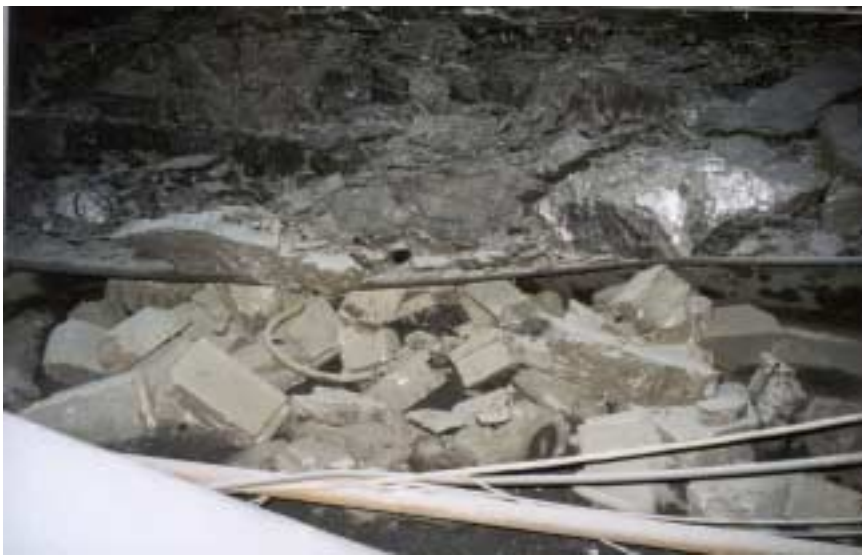
Figure 17: Looking into the #3 entry from the crosscut between spads #13200 and #13199. Stopping material along with the damaged conveyor belt system deposited along the left rib in the #3 entry can be seen.

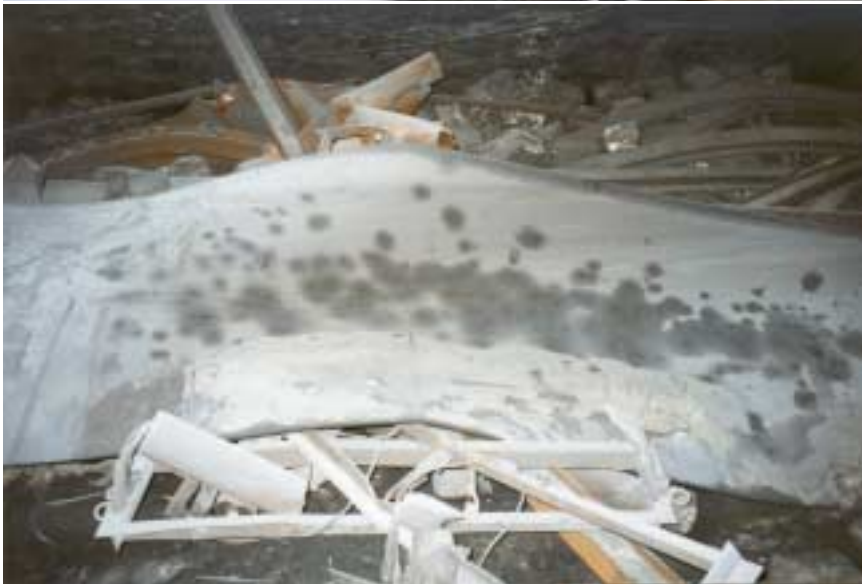
Figure 18: Looking into the #3 entry from the crosscut between spads #13039 and #13048. The steel beams, steel plates, and concrete blocks from the belt/return overcast along with material from the conveyor belt system were deposited along the left ribline of #3 entry. Note: In the upper portion of the picture the steel beams from this overcast can be seen twisted and bent.

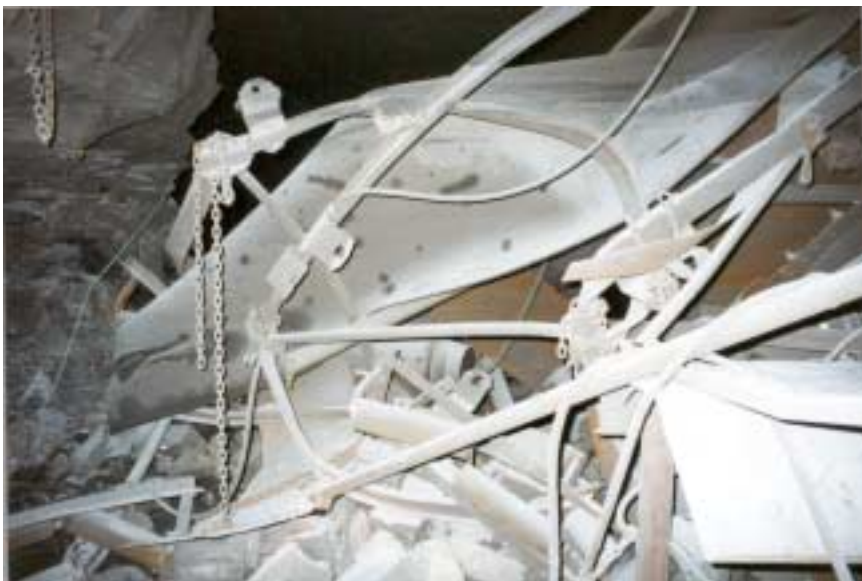
Figure 19: Taken from the left of spad #13038 looking inby into the #3 entry of the left ribline at the No. 4 section header. Concrete blocks from the inby overcast can be seen at the bottom of the picture.

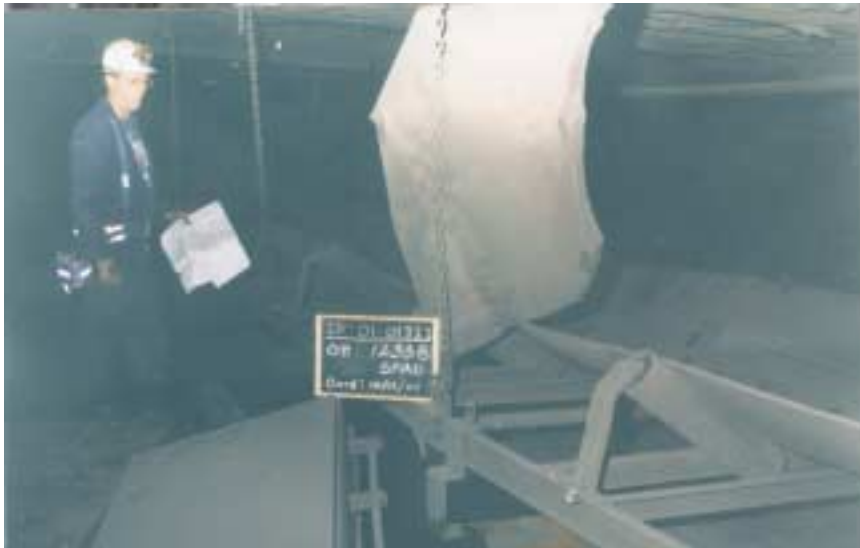
Figure 20: Looking outby from spad #12338, located in the #3 conveyor belt entry of 3-east. A piece of a belt vulcanizer is blown into belt structure. This picture also shows how the conveyor belt system at this location was only slightly damaged.

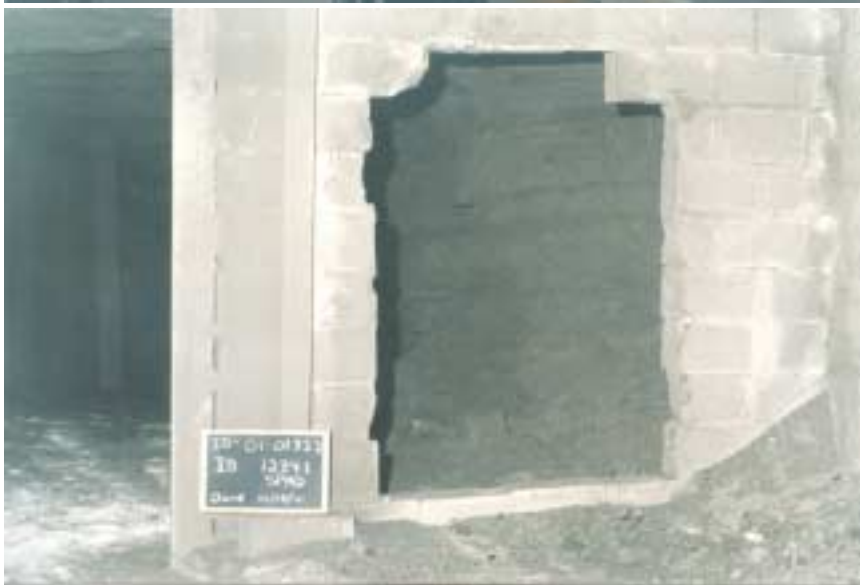
Figure 21: Looking outby toward spad #12341, located in the #1 entry of 3-east. This picture shows damage to 3-east return regulator.

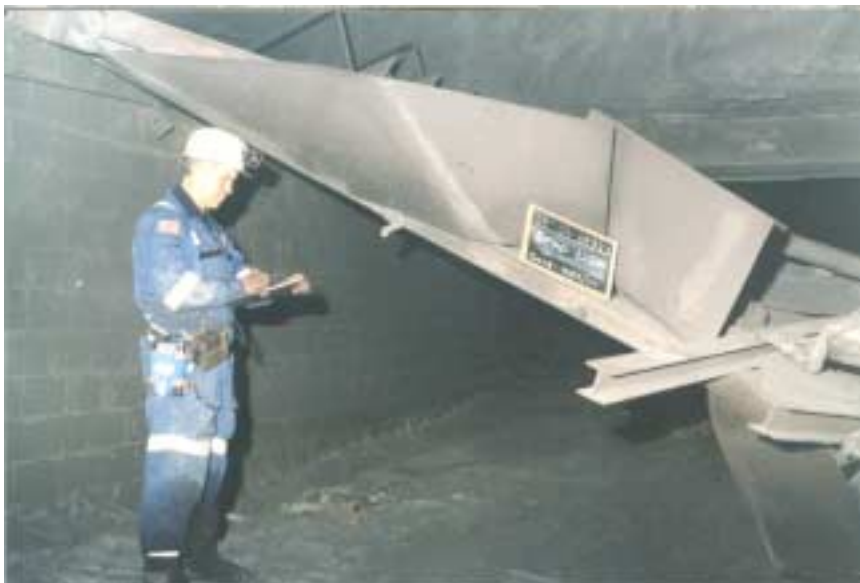
Figure 22: Looking outby at spad #12285. Picture shows damaged vercast.

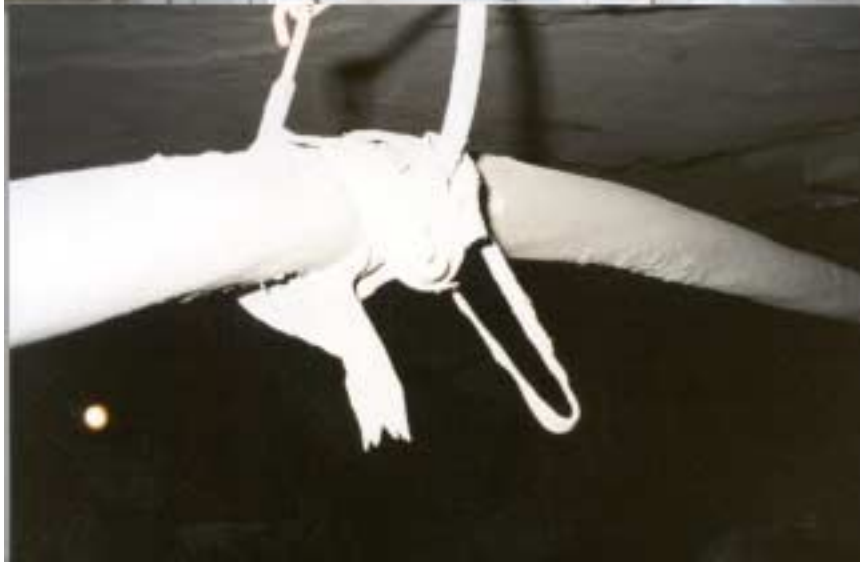
Figure 26: Located at the left outby rib corner at spad #13231 in the #2 entry. Picture is of a “J”hook and shielding melted into high voltage cable.

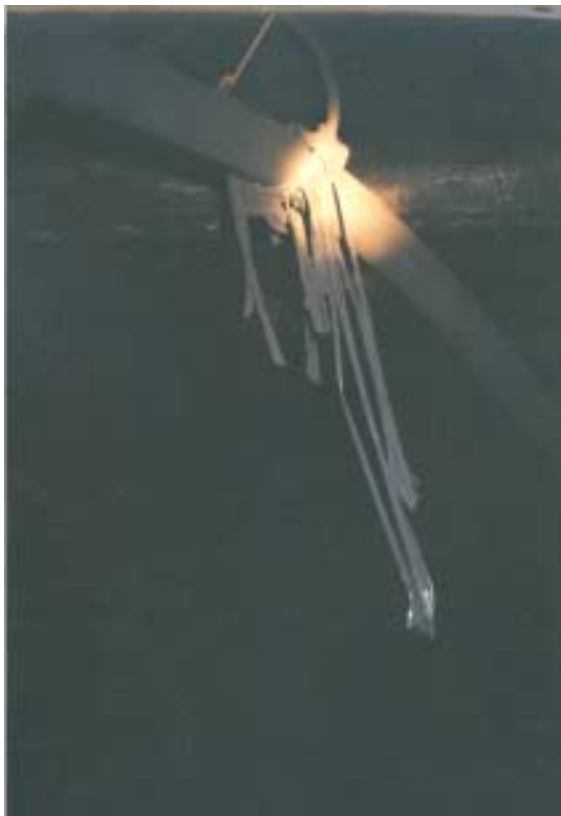
Figure 27: Located along the left rib of #2 entry at spad #13319. Picture of melted shielding hanging off high voltage cable.

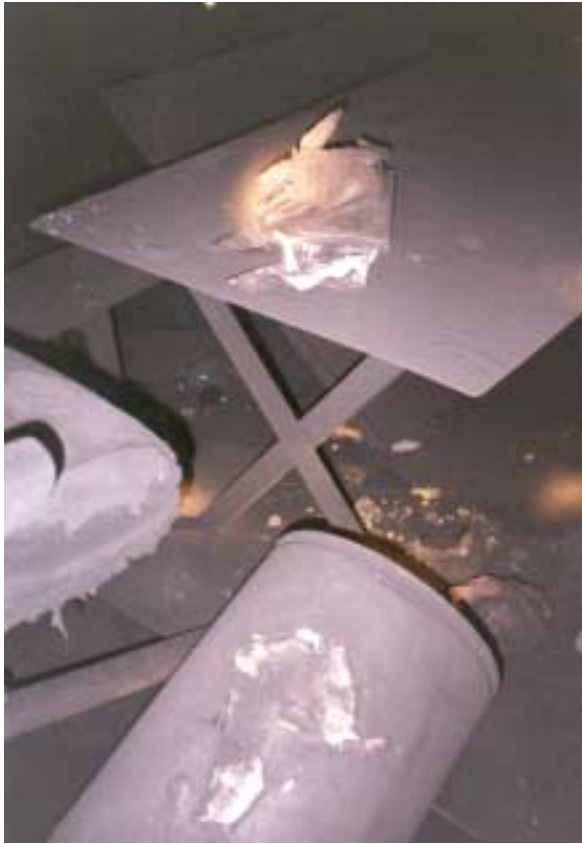
Figure 28: Located near the outby left corner at spad #13348. Picture of the effects of heat on trashcan, edge of seat and a book on the table.

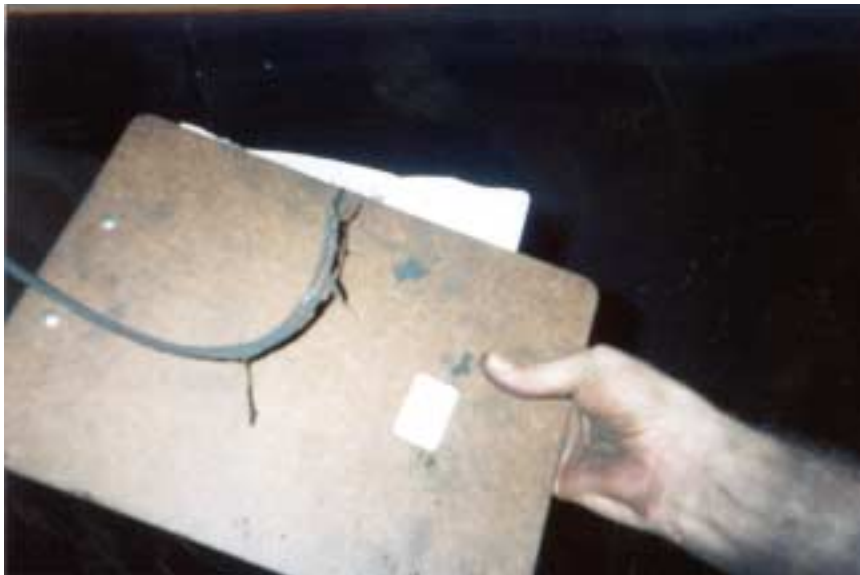
Figure 29: Located near the inby left corner at spad #13348. Picture of melted insulation jacket of phone cable.

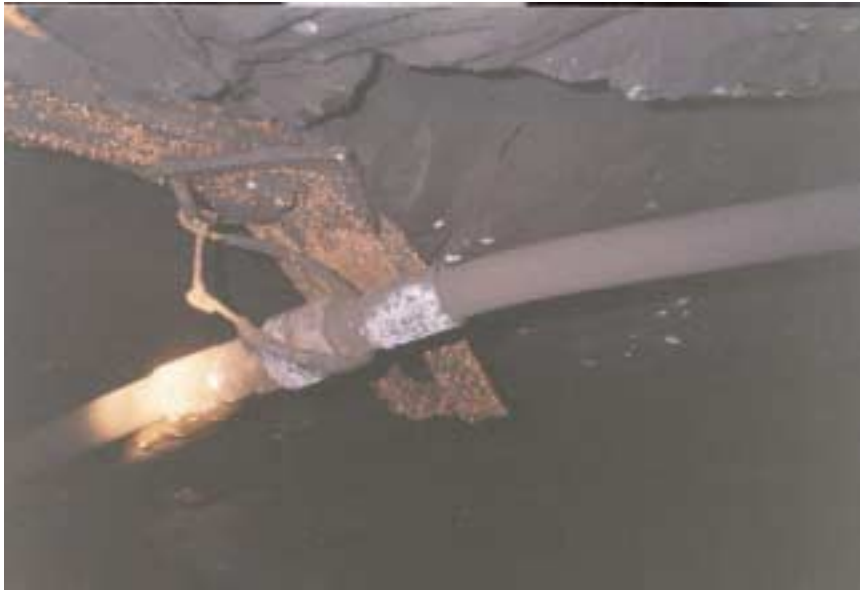
Figure 30: Located in the #1 entry inby spad #13349 along the right rib. Picture of a melted “J” hook on the continuous miner water line.

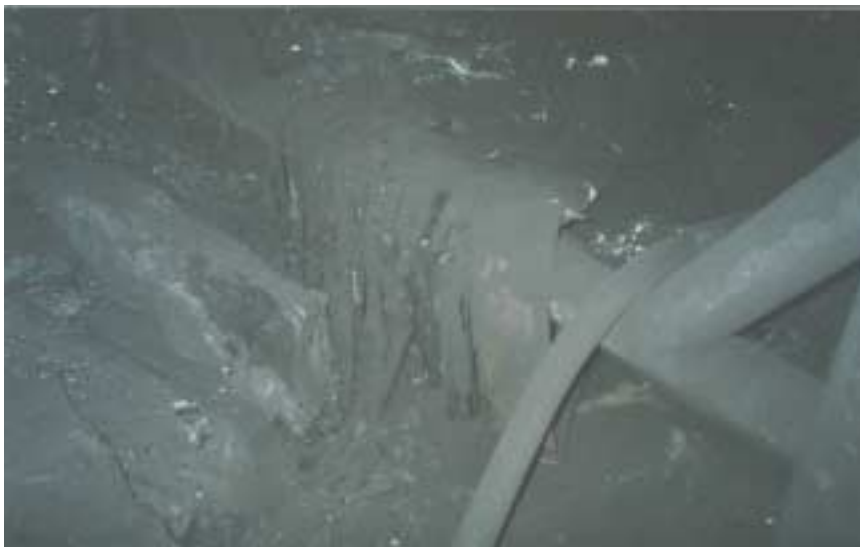
Figure 31: Located in the #3 entry along the inby ribline of the last open crosscut between spad #13352 and spad #13353. Picture of melted resin cartridges on the supply sled.

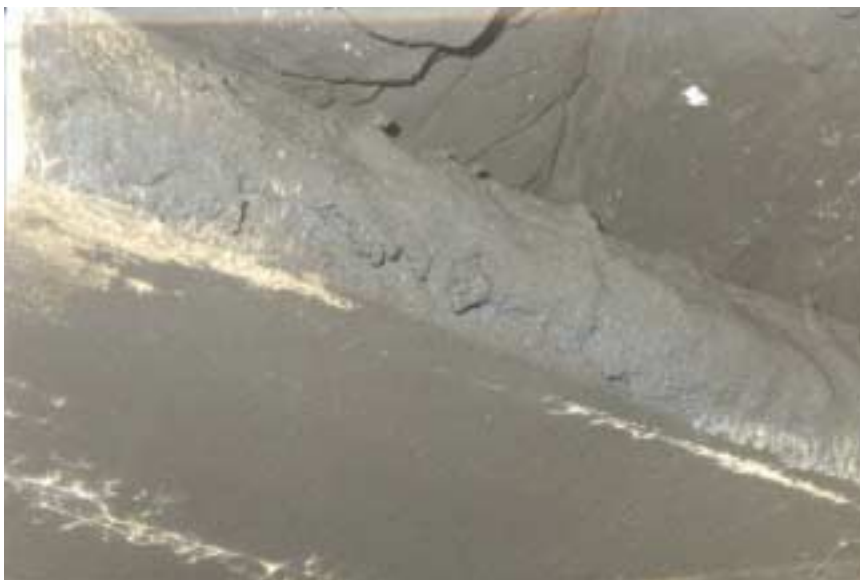
Figure 32: Located in the last open crosscut between spad #13352 (#2 entry) and spad #13353 (#3 entry), 50 feet into the crosscut from #3 side. Picture of coking on “T-Board”.

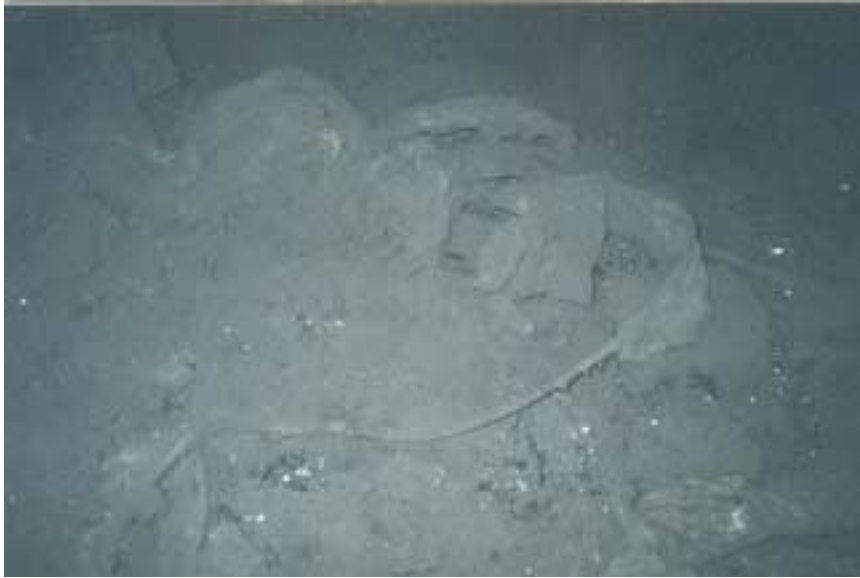
Figure 33: Located in the #3 entry at spad #13353. Picture of melted curtain line material.

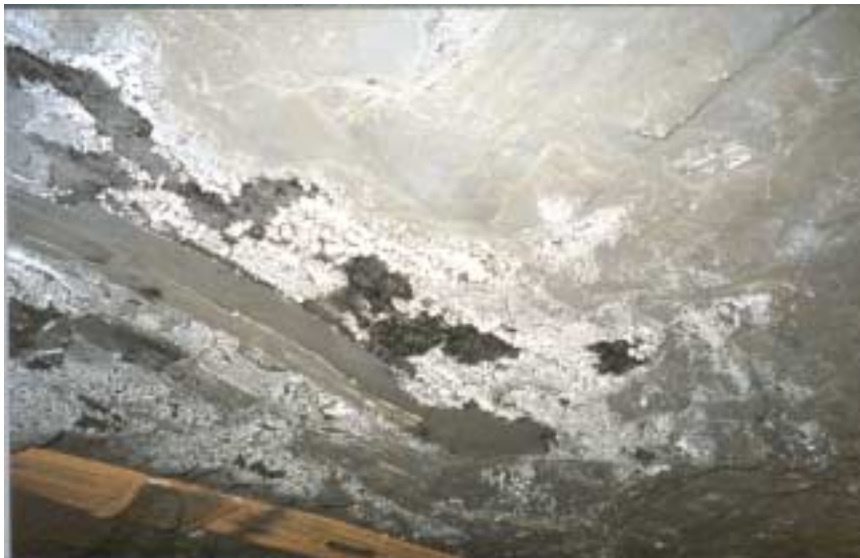
Figure 34: Located in the #3 entry inby the last open crosscut (Inby spad #13353). Picture of coking on the roof starting 30 feet outby the #3 face.

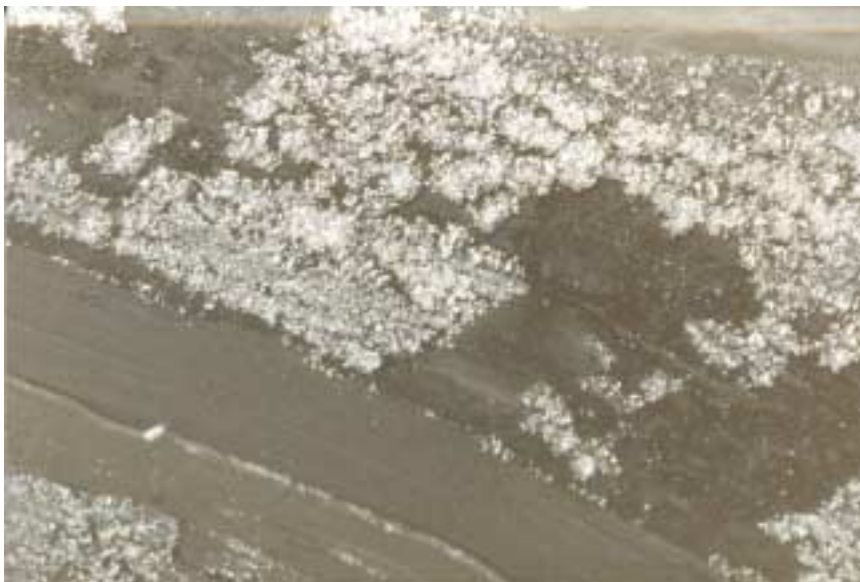
Figure 35: Picture of coking on the roof starting 30 feet outby the #3 face.

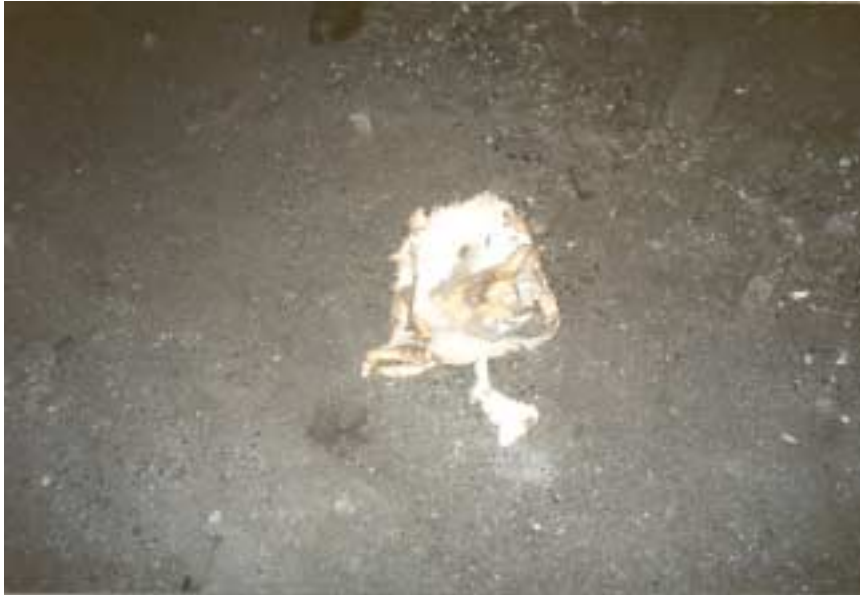
Figure 36: Located in the #3 entire inby the last open crosscut (Inby spad #13353). Picture of burnt paper sack located 20 feet outby the face and four feet off the left rib.

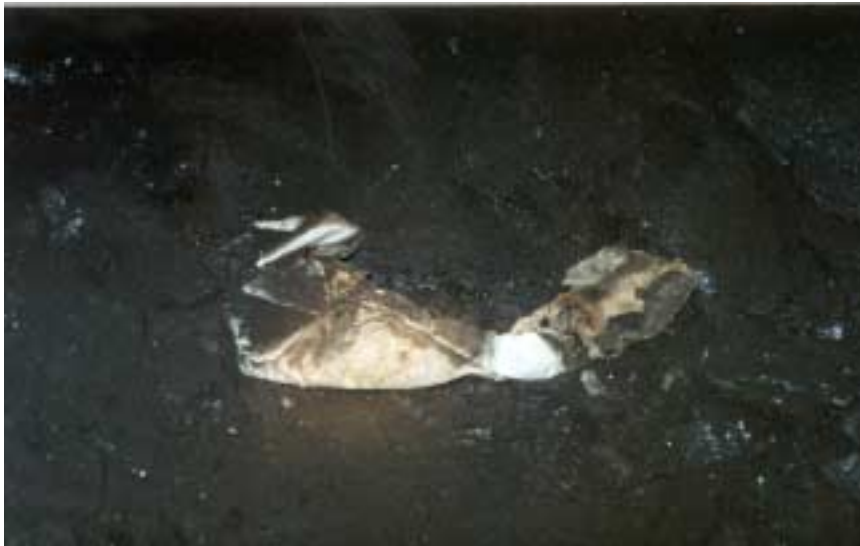
Figure 37: Located in the #3 entry inby the last open crosscut (Inby spad #13353). Picture of burnt paper sack located at the #3 face, in the center of the entry.

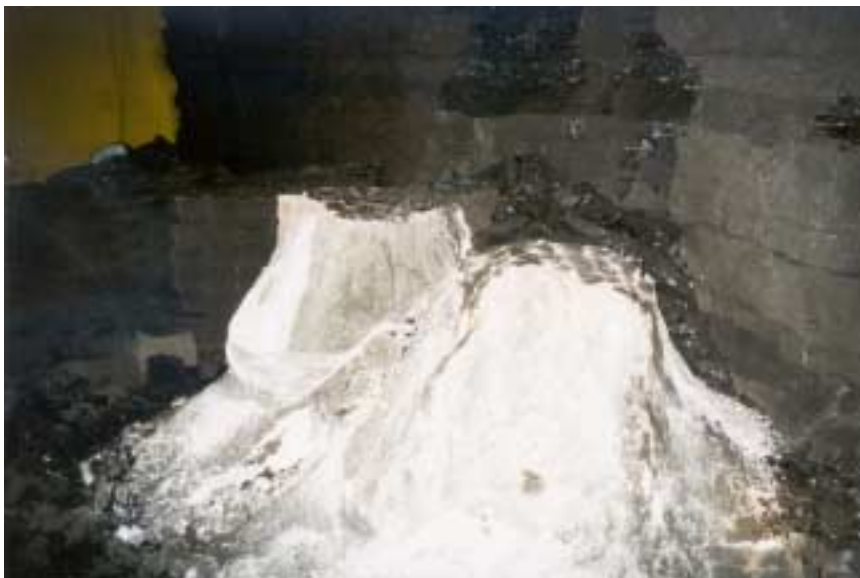
Figure 38: Located in the #2 entry and in the area of the rock fall along the inby ribline in the crosscut between spad #13333. Picture of two big rock dust bags melted or burnt away exposing dust.

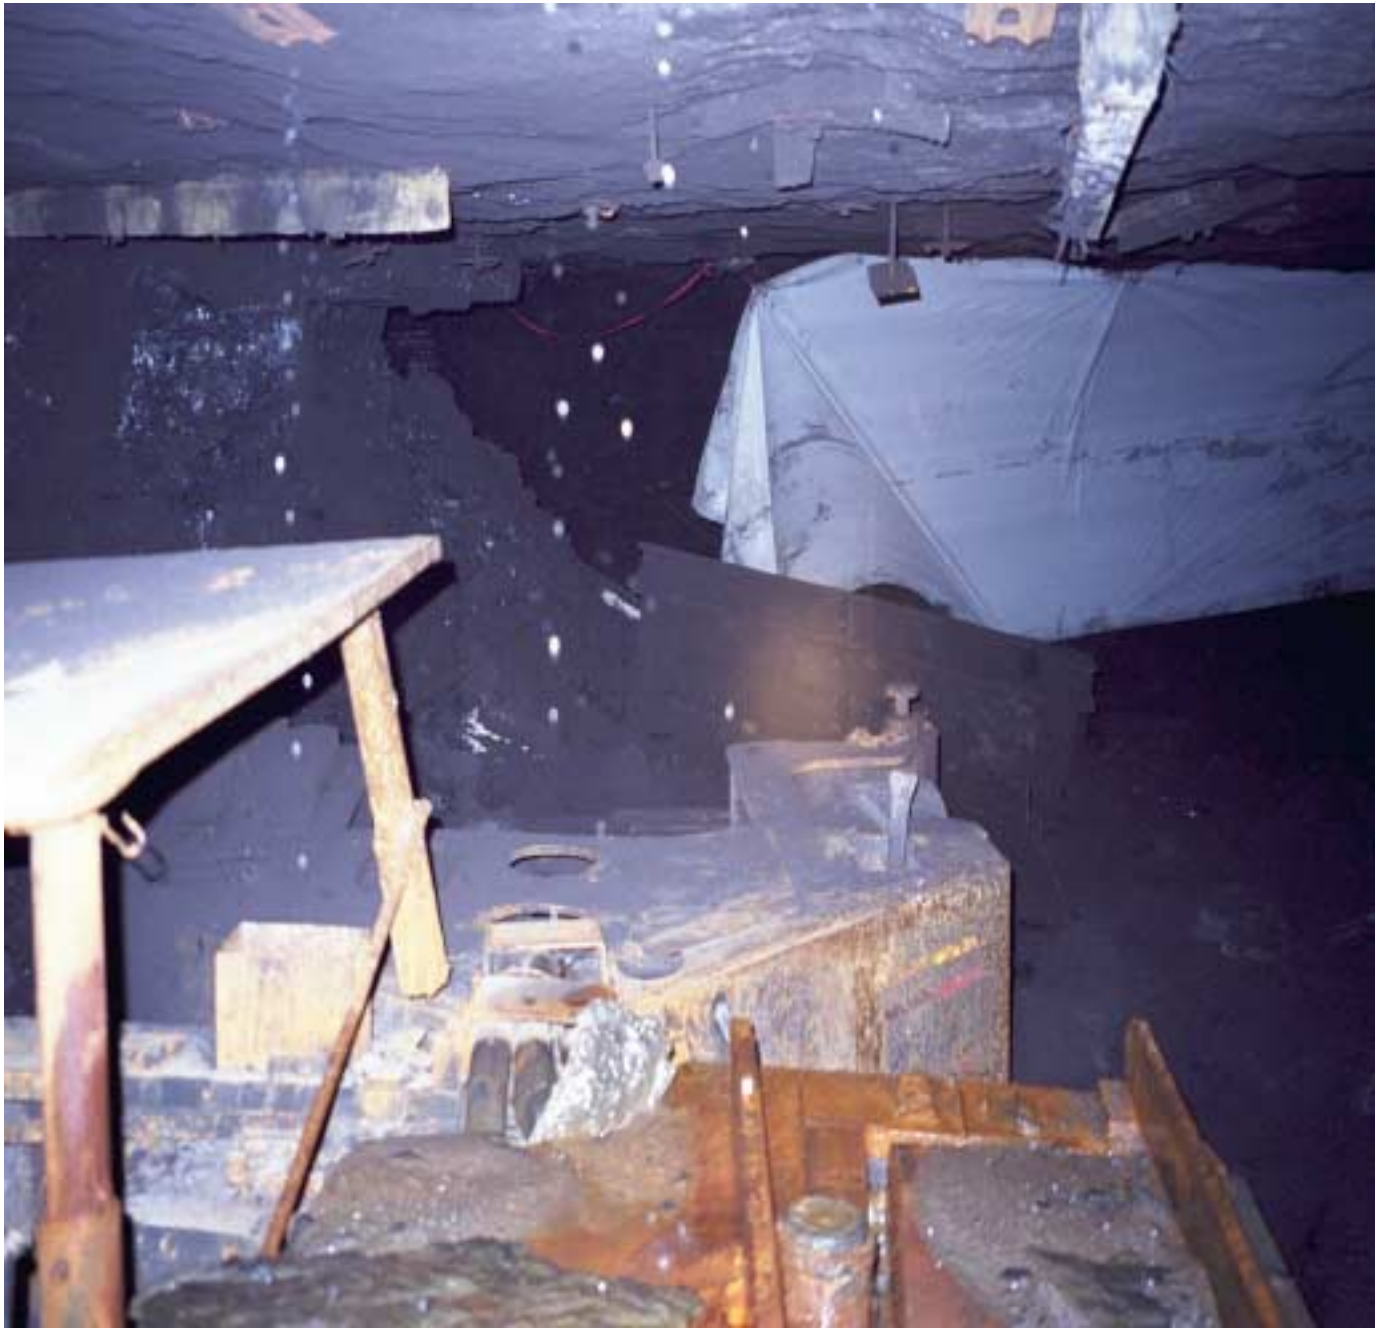
The roof of the crosscut above the scoop between Spad 13352 in the #2 entry is shown without any straps installed. This was evident in all the crosscuts between # 1and # 2 entries even when the slips and joints were well-defined in the roof of the crosscuts.
